The Road Inventory of Sutter River National Wildlife Refuge Yuba City, CA

Prepared By:
Federal Highway Administration
Central Federal Lands Highway Division
May 2012

Sutter National Wildlife Refuge - 81623

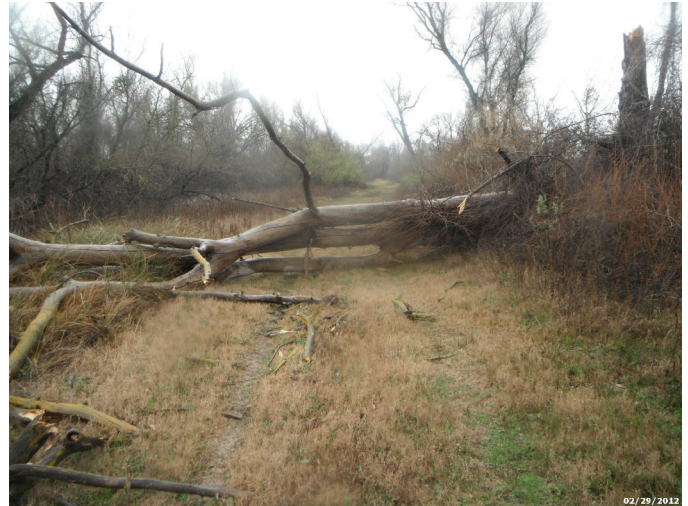
Photo: SUTT_C4_1797 Route: 408-001-0.39
Problem Area Tree down over route
